NASA CR-135051 CASD-NAS-76-018

THERMAL PERFORMANCE OF A CUSTOMIZED MULTILAYER INSULATION (MLI)

FINAL REPORT

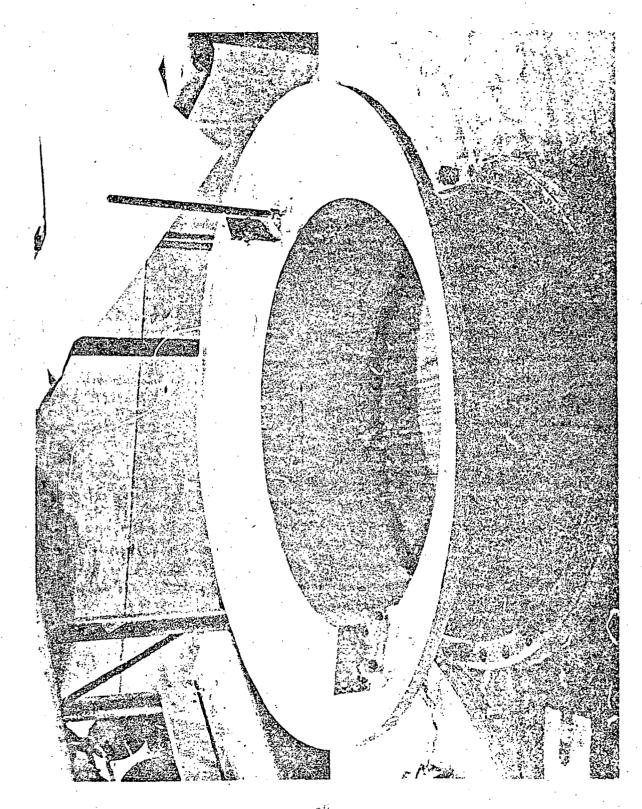
Figure 3-2. 1.52 m (60 in) Tank After Large Manhole Access Door Cutout

Figure 3-2 shows the cutout of the manhole access door ring. Figure 3-3 indicates the cutout area distortion. Note the difference in thickness at various locations of the cutout. A closeup of the distortion measurements by the dial indicator at the door ring cut is presented in Figure 3-4. Figure 3-5 shows the setup of the tank on the Bullard Boring machine to correct the distortions of the manhole access door area and to complete the cutout for the new door ring.

The majority of the problems encountered during the preparation of the tank welding can be directly attributed to the initial fabrication of the 1.52 m (60 in) tank by its original manufacturer. It was noted that there was an excessive amount of trapped welding stresses and distortions which were relieved when the door rings were removed. In addition, there was a large variation in parent metal thickness adjacent to the location where the new components were needed. The problems were magnified by the variations in wall thickness in the existing conical tank support weld area resulting from mismatching the tank halves, as shown in Figure 3-6. The mismatch was corrected by the original

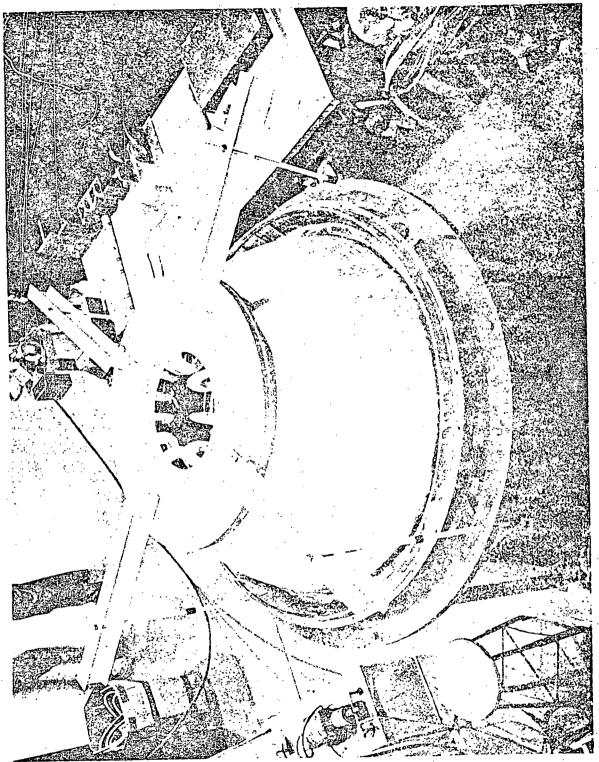
Figure 3-8. Tooling Aid to Correct Large Manhole Access Door Ring Opening

After completion of the tank outlet cap weld, the door ring cutout was approximately 0.00178 m(.070 in) out-of-round. The problem was corrected by fabricating a tooling aid to correct the ring opening. The tooling shown in Figure 3-8 consisted of an aluminum ring, 0.051 m (2 in) thick and 1.22 m (48 in) outside and 0.736 m (29 in) inside diameter, with four aluminum I-beams and threaded rods. The rods were used to apply pressure on the aluminum ring to correct the out-of-round condition. By applying pressure, the 0.00178 m (0.07 in) out-of-round was reduced to 0.000254 m (0.01in) which was adequate for inserting the ring to be welded. The welding procedure used to weld the door ring to the tank was the same as that for the cap welding. The internal welding of the ring to the tank is shown in Figure 3-9.
